KOKNESE FRONT FORTIFICATIONS. TOO BIG TO BE SEEN

Dr.hist., Dr.habil.art. Juris Urtāns

Latvian Academy of Culture, Latvia

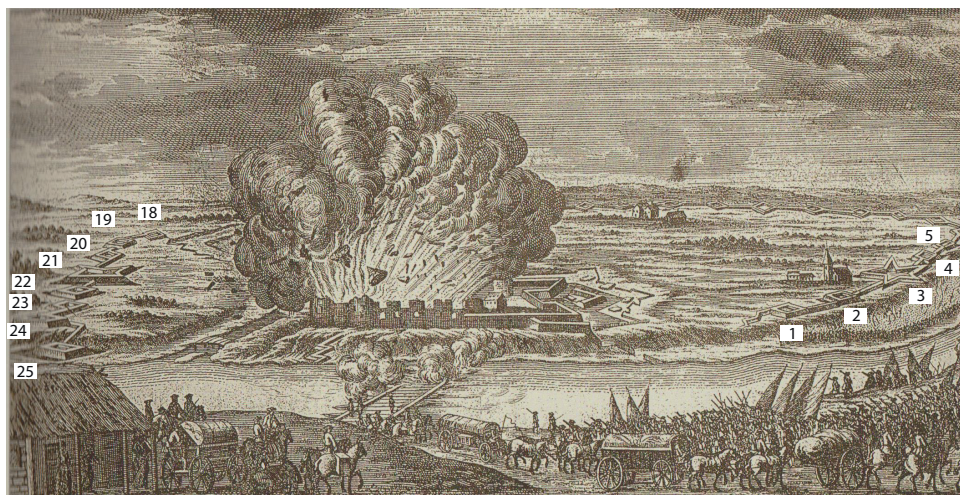
Figure 1. Koknese Fortress with front fortification line in 1701 (in: Broce, 2002, 259), with the present numbering of localized and matched redoubts. Prepared by J. Urtāns, drawn by R. Delters.

A lithograph depicting blowing up Koknese Fortress in 1701 is essential in understanding and investigating Koknese front fortification line, which has been accurately displayed in the lithograph (Figure 1). Author of the lithograph is not known with certainty; it is possible that the author was Swedish engineer Johan Liten [Malvess 1968a: 43–44]. J. C. Brotze wrote that this copper engraving was wrong in many ways, and J. C. Brotze's commentators agree with him [Broce 2002: 259], but R. Malvess asked them to be critical about such statement [Malvess 1968a: 43–44]. Possibly depiction of blowing up the fortress and movement of the troops might be treated more critically, but depiction of redoubts of the front fortification line at least on the right bank of the Pērse at Koknese church seems quite feasible.

Comparing the location of redoubts of the right bank of the Pērse with the redoubts shown in the lithograph, it can be stated that type of redoubts and their layout both in the depiction and *in situ* is appropriate. In the lithograph, the central four-pointed redoubt has been shown as the largest, as it is also *in situ*. However, in NE part of the front fortification system in the lithograph, more redoubts have been shown than exist in reality.

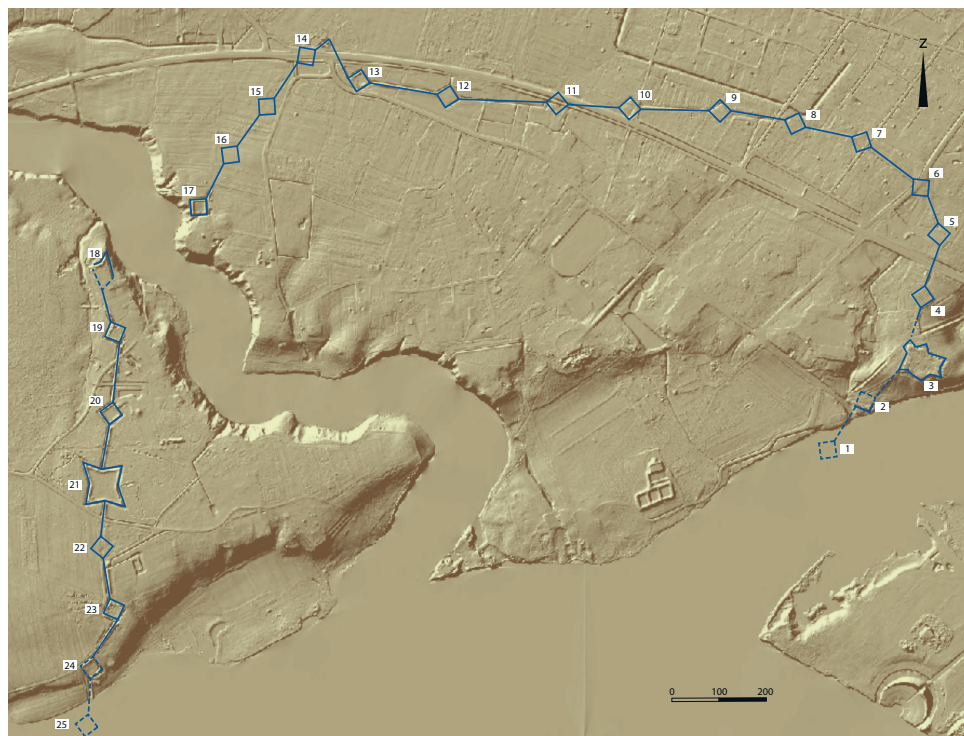
Figure 2. Koknese front fortification line in aerial laser scanning with the present numeration of redoubts. Prepared by J. Urtāns, drawn by R. Delves.

In Koknese front fortification line seven (12–13, 17, 20–21, 23–24) redoubts with appropriate ditches and inner formation have been well preserved, five (2–3, 9–10, 18) redoubts have been partly preserved, in aerial laser scanning materials sites of six redoubts (5–8, 11, 15–16, 22) can be suspected, there is lack of convincing information concerning two (1 and 25) redoubts, because the sites have been flooded by waters of the Daugava water-reservoir (Figures 2, 3).

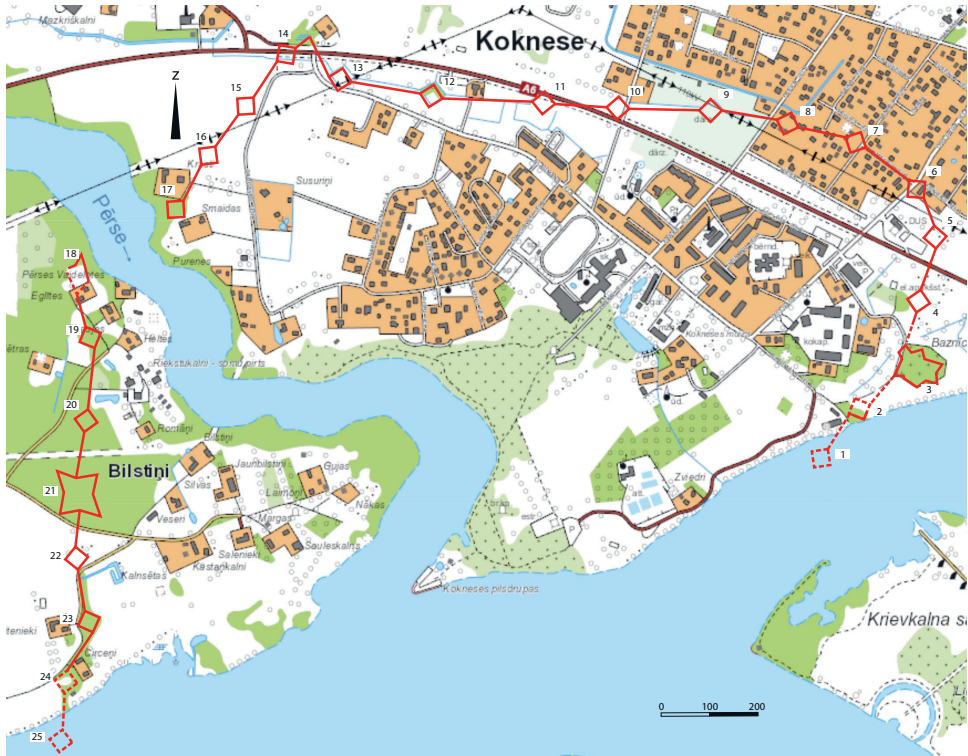
Figure 3. Koknese front fortification line on contemporary map with the present numeration of redoubts. Prepared by J. Urtāns, drawn by R. Delvers.

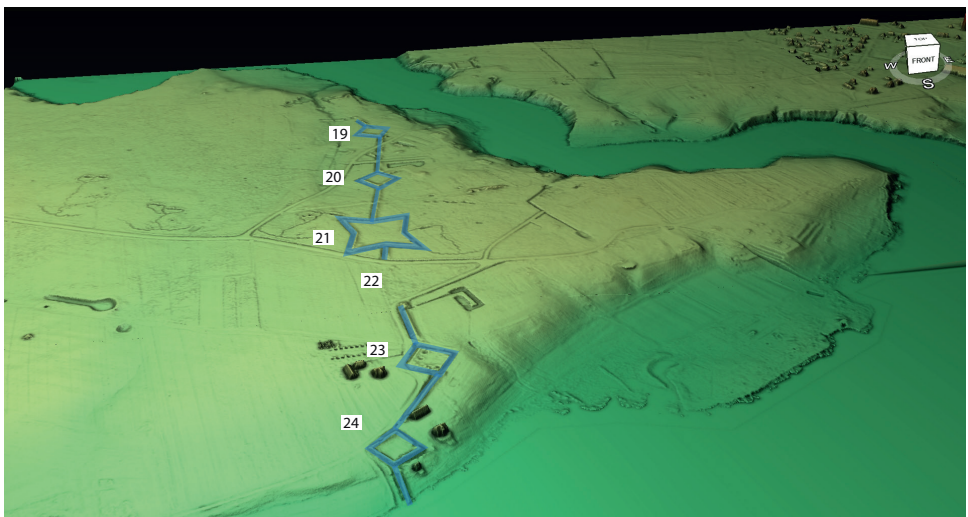
Figure 4. Redoubts 19–24. 3D model. Developed by G. Kalniņš.

Redoubt 20 has been well preserved. All four glacis and ditches are clearly outlined (Figure 4). In more recent times soil has been shoved on its NE glacis and the ditch from outside. Inside the redoubt, a parapet up to one metre high has been preserved. The ditch to S of the redoubt has also been well preserved. It runs against the breach of the central part of redoubt 21, not the corner as in other redoubts. The ditch between both the redoubts has been ravaged by a road, once used, which is now overgrown, possibly associated with the First World War.

Redoubt 21 should be considered to be one of the two key redoubts, it is large and differently shaped from other redoubts (Figure 4). Possibly, by importance on W side of the fortification line, it has been similar to redoubt 3 on E side of the fortification line. Redoubt 21 has been preserved relatively well. It had been four-cornered, but each glacis had a breach in the central part. Therefore, the four corners of the redoubt resemble bastions. Inner parapet has survived in places inside the redoubt. NW corner has been damaged by dug-up ground which has been connected to, possibly, trenches of the First World War. Similarly, but to less extent, E glacis and SE and SW corners of the redoubt have been damaged. The redoubt is larger than other redoubts by its dimensions (approximately 130 and 140 m between opposite corners), but the height and sizes of the ditches are roughly the same as other redoubts. From the breach point of S glacis of the redoubt, a ditch splits off towards redoubt 22, which ends at the road that leads to Bilstiņi. On the other side of the road there is a field where the ditch is not visible anymore.

Redoubt 23 is marked by breach fortification system; here the fortification line turns more to the W. Fortification ditches and glacis of the redoubt are well outlined (Figure 4). Inside the redoubt, in its NW and SW there are pits of more recent dug-ups. From NW and SW right past the redoubt, partly levelling the fortification ditch, leads the homestead road, which is further parallel to the ditch with a parapet between redoubts 23 and 24. In the place where the ditch is connected with redoubt 24, it has been filled up, building the driveway into the yard of *Circeņi* homestead.

Redoubt 24 is situated next to *Circeņi* homestead, to W from the latter and joins in the household. Well outlined redoubt (Figure 4) has become a peculiar yard enclosed by the rampart with several dug-up places. NE glacis of the redoubt had been levelled lower in earlier times. There is a dug-up of the rampart at SE corner of the redoubt, which allows entrance inside the redoubt. Inner parapet in SE part on the top has been dug over with war-time trenches. A bigger dug-up is also in SW glacis of the redoubt. To S from the corner of the redoubt, unmistakable fortification ditch with a parapet on E side stretches as far as the edge of the Daugava water-reservoir.

Existence of **Redoubt 25** is confirmed by lithograph. The existence of redoubt 25 is indirectly testified also by a ditch that had been dug to S from redoubt 24 (Figure 4). The outline of the redoubt is probably shown in aerial photograph.

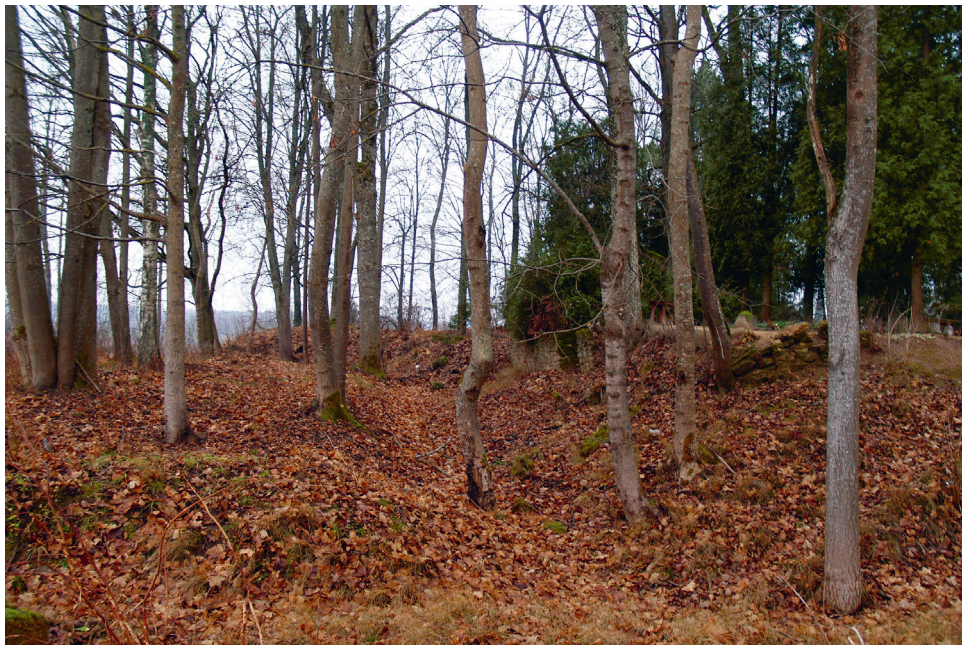
Figure 5. East fortification ditch of redoubt 3, with a breach and today's cemetery.
Photo by J. Urtāns.

Redoubt 3 in the lithograph has been depicted as a fortification in the shape of a five-pointed star, where each point of the star could be regarded as a separate bastion. Site of the redoubt was later adjusted to fixing up a cemetery, therefore the common shape of the redoubt as a five-pointed star, separate glacis and ditches cannot be discerned with certainty anymore. Outer shape of the redoubt has been best preserved in the direction towards the Daugava, where a bastion and its glacis on NE (Figure 5) and SW sides has been fairly well preserved, as well as a ditch to NE

and SW from the bastion. To S the ditch of the redoubt turns, possibly, pointing at S bastion, but it has been largely levelled and transformed because of the cemetery. It is possible that half of SW bastion has survived. Inside of the redoubt and all the corner bastions is occupied by graves. The fortification ditch in the direction to redoubt 4 is not visible. Redoubt 3 has been one of the two main redoubts of the fortification line, the most important one on E side of the fortification system, it is estimated to have been 130 m across. Redoubt 3 was situated on a high bank of the Daugava; it had a good command of vast surroundings.

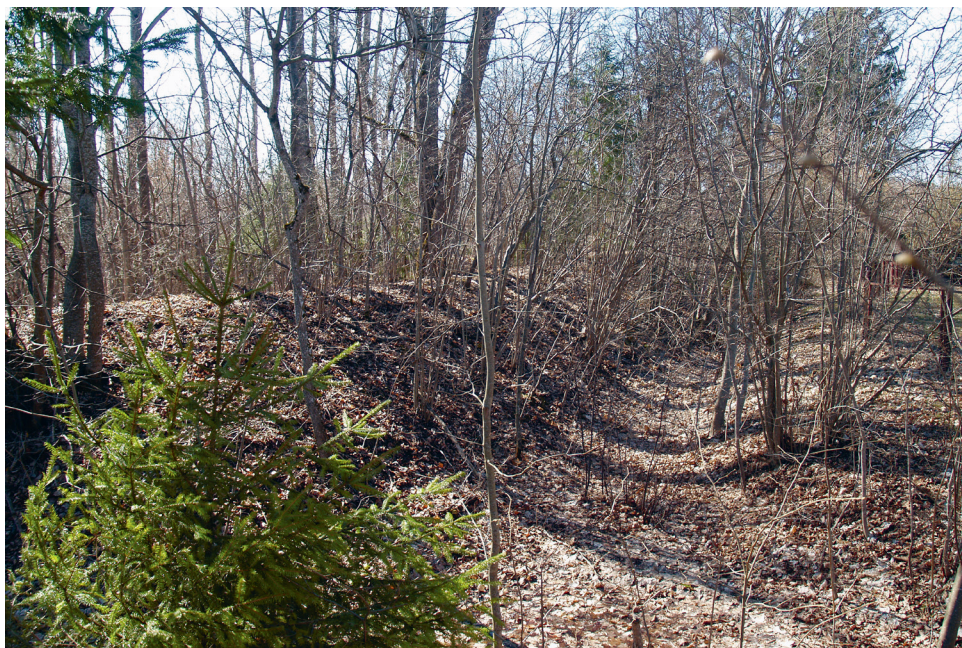
Figure 6. North glacis of redoubt 17 and ditch. Photo by J. Urtāns.

Redoubt 17 is situated on the left bank in the former Valley of the Pērse River between *Krasti* and *Smaidas* homesteads. Four-cornered redoubt has retained all four glacis and a ditch (Figure 6), only N glacis and the ditch have been disturbed by some older dug-ups. The ditch encircles the whole redoubt, but opposite the steep bank of the Pērse, where it was of less importance, the ditch is shallower. Inside the redoubt, a parapet has been preserved at 1–1.5 m height, which might have been its initial height. In direction towards redoubt 16, at NE corner of redoubt 17, a ditch

begins, which ends at the driveway to *Krasti* homestead, but this ditch seems to have been dug in more modern times. Redoubt 17 is the last one on the left bank of the Pērse River. It is not visible in the lithograph, because it is screened by the smoke column of the explosion. Redoubt 17 has been best preserved of all the redoubts of the line.

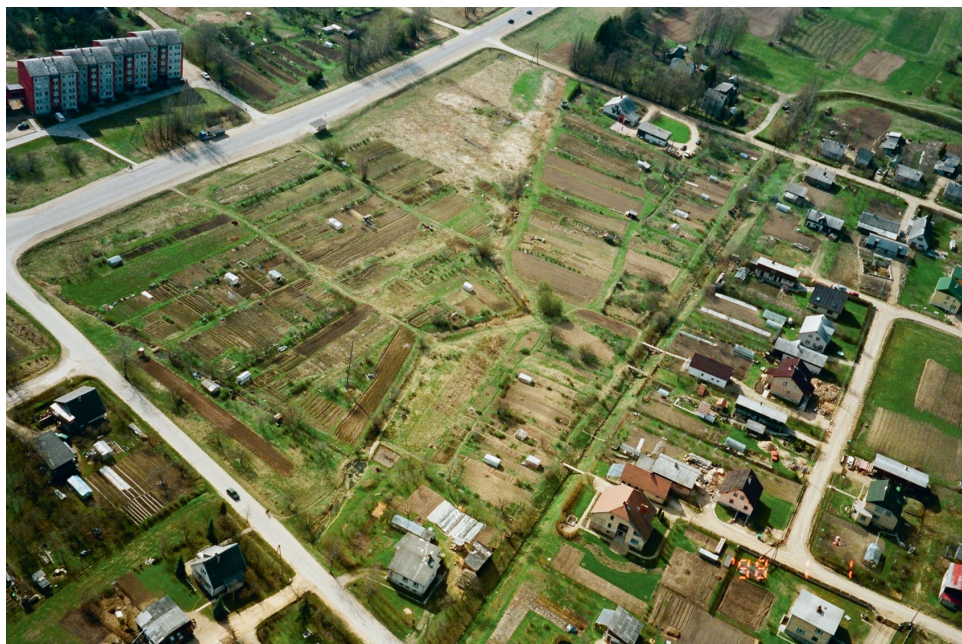
Figure 7. Remains of redoubt 9 and fortification ditches from bird's eye view.

Redoubt 9 is situated in territory of allotments (Figure 7). The redoubt is well marked by the corner directed to N with ditches and glacis on both sides. The redoubt had been quadrangular, its S side has been levelled and cannot be discerned. The fortification ditch from redoubt 9 against redoubt 8 fairly well marks itself only

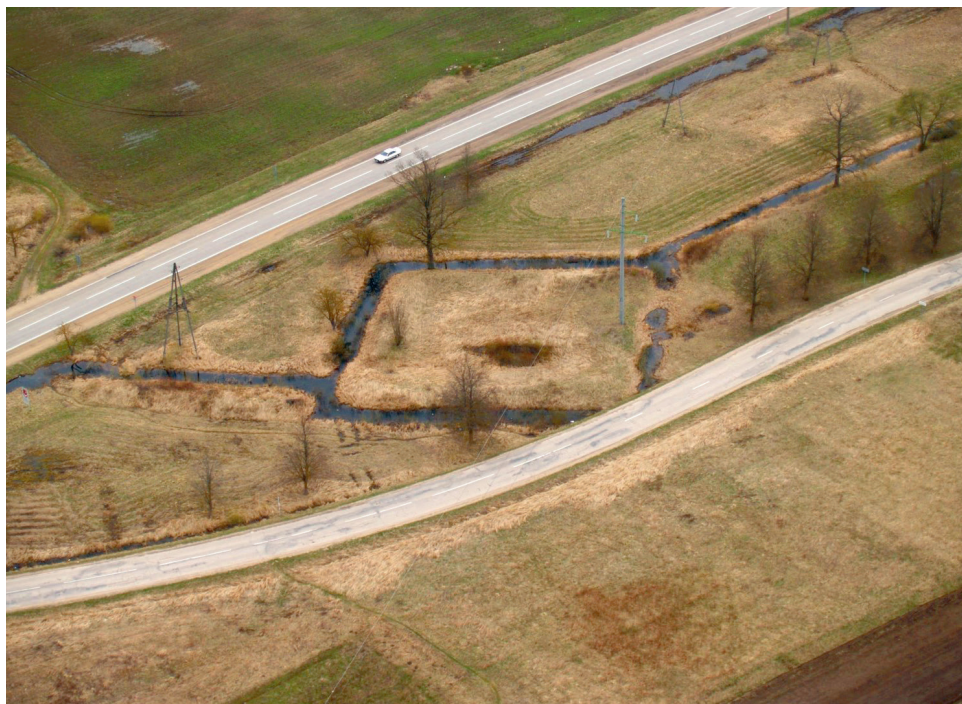
Figure 8. Redoubt 13 and fortification ditches from bird's eye view. Photo by J. Urtāns.

Redoubt 13 is situated between the old and the new Rīga – Daugavpils motorway (Figure 8). The redoubt, like the fortification ditch between redoubts 12 and 13, can be well distinguished. It is not quite clear how the fortification ditch joins the W corner of the redoubt. There is a ditch, dug in more recent times, which at N corner of the redoubt is connected with amelioration ditch, which as a culvert runs below the new Rīga – Daugavpils motorway. If it is assumed that this ditch had been built in the place of the old fortification ditch, it might direct to redoubt 14. This ditch can be suspected also in the aerial photograph.

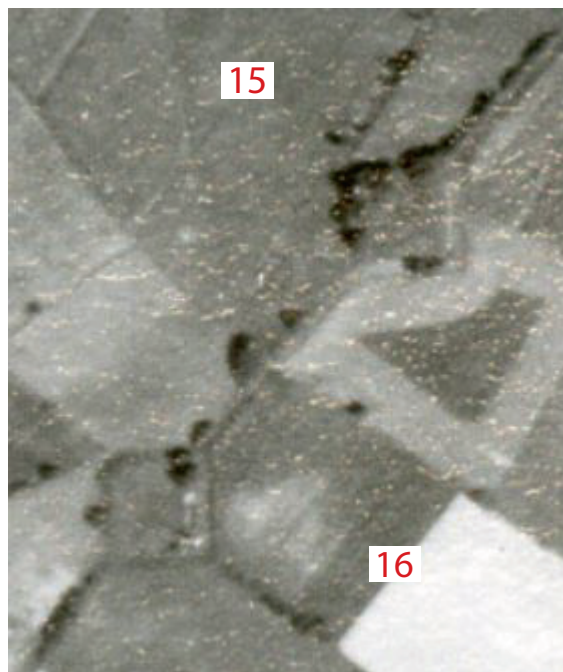
Figure 9. Redoubts 15 and 16, and connecting ditches, not levelled yet. Aerial photograph of the Second World War.

Redoubt 15 and its ditches have been completely levelled, it has no outer visual signs, but in the aerial photograph, aerial laser scanning and modern aerial fixation, the four-cornered redoubt and its N side ditch can be unmistakably distinguished. On the site of the redoubt, which is situated next to *Daugavas* street, there is a field and a small protrusion in relief. The ditch connecting redoubts 15 and 16 cannot be distinguished in aerial laser scanning; it is well visible in aerial photograph. It is likely to have been destroyed by construction of *Daugavas* and *Blaumaņa* streets, because the probable route of the ditch should lead exactly along these streets.

Redoubt 16 has been totally levelled, now in its place there is a small protrusion in relief and a field. Outline of the redoubt can be noticed in aerial laser scanning; it can be seen also in aerial photograph (Figure 9).

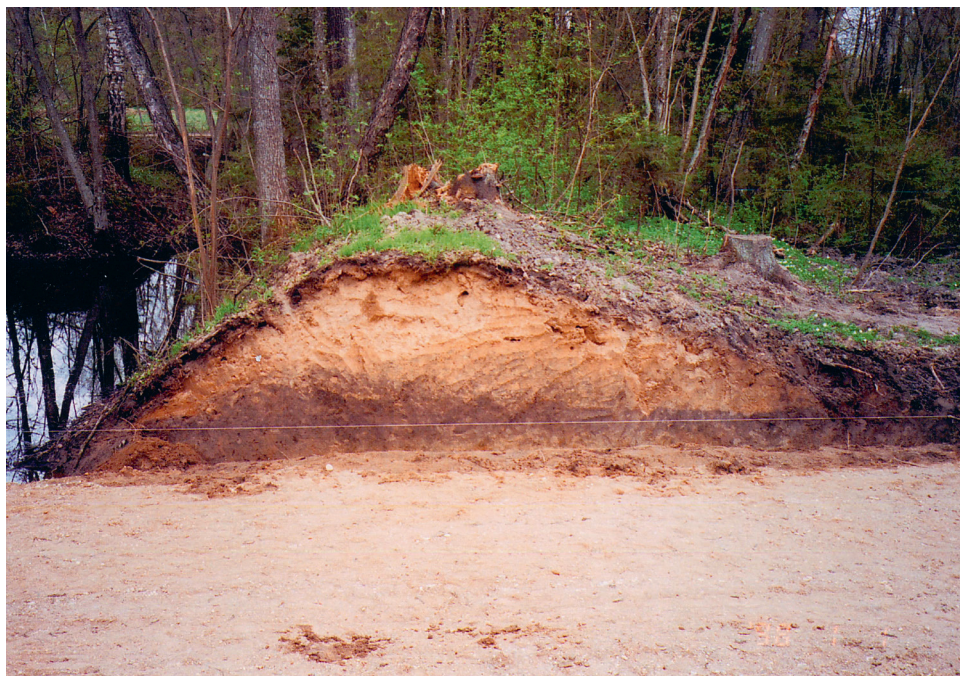
Figure 10. Section of rampart between redoubts 19 and 20. Photo by J. Urtāns.

In the spring of 2004, a profile of the ditch and parapet was filed in digging over this road in the course of archaeological supervision (Figure 10). It turned out that the rampart at its base was approximately 8–9 m wide, but fortification ditch – 5.5 m wide. The depth of the fortification ditch from surface level of water at the moment of fixation exceeded one metre, however, it must be taken into account that the ditch might have become shallow in more modern times. Height of the rampart above the former soil level is 1.8 m. Judging by the profile of section, the process of building the rampart might have been as follows: at the beginning turf was dug off the surface of the ditch to-be, and was thrown where the rampart would be, close to the ditch on undisturbed layer of turf (dug-off layer of turf is slightly thicker where it is closer to the ditch); then the loamy soil dug out of the ditch was put on the black layer of turf and filled the nucleus of the rampart to-be. It is possible that there had been some kind of fencing (*fascine* ?), which kept together the soil thrown out of the ditch. This delimiting enclosure is probably indicated by a steep abrupt edge or step in the section of rampart. Defenders of the fortification could move along it. When

the upper part of the fortification rampart was built, sand was poured there, which had been transported from some other place, because there is no light sand in the proximity of rampart section. The rampart had been built in such a way that it was steeper against the ditch, but gently sloping on the opposite side. It is possible that the sand had not been heaped up simultaneously with construction of the lower part of the rampart, i. e., sand had not been put immediately on the black and loamy soil dug out of the ditch, but sometime a bit later. Perhaps this could be explained by building of the rampart in two stages – in the autumn of 1700 and then in the spring and the beginning of summer of 1701. The heaped-up rampart started to subside in the course of time, filling up and covering the step. On checking both dug-up edges and section site with metal detector, no metal objects were found that might be associated with the time of building the fortification line.

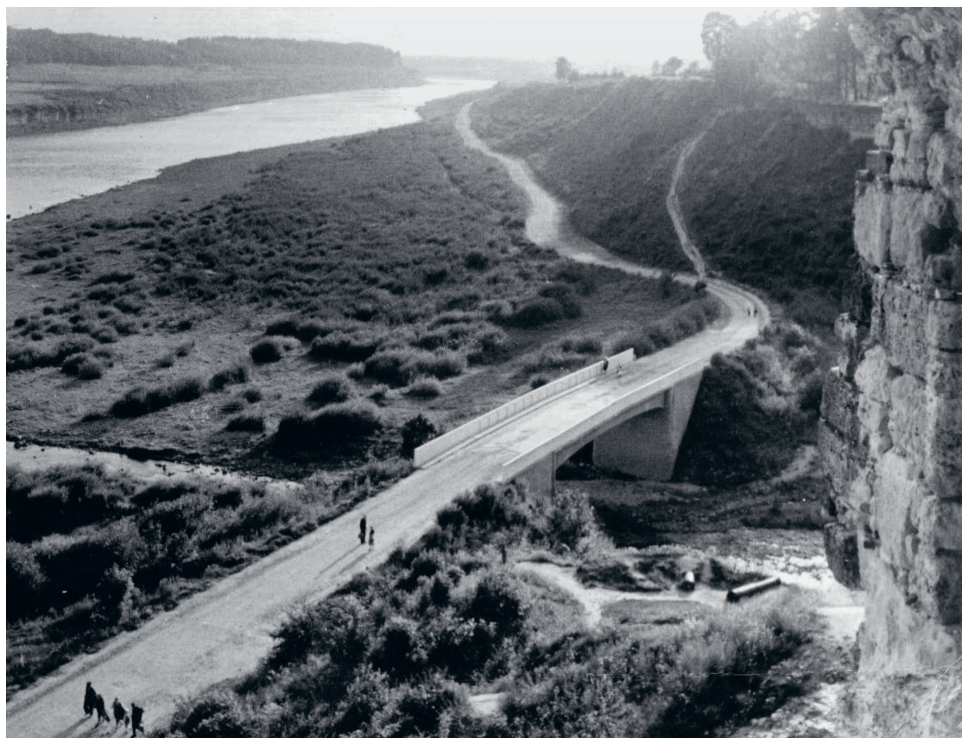
Figure 11. View of probable redoubt 25 and fortifications on the slope of the Daugava Valley. Postcard. 1930s. J. Urtāns' collection.

A protuberance in probable place of redoubt 25 is seen also in an old postcard (Figure 11). This place has been flooded, but it is not unlikely that the redoubt has been preserved under the water.
